Forensic Geotechnical Evaluation of Challenges in Constructing the Flood Protection Infrastructure (Wall) at Kadana Powerhouse, Gujarat, India

Original research paper

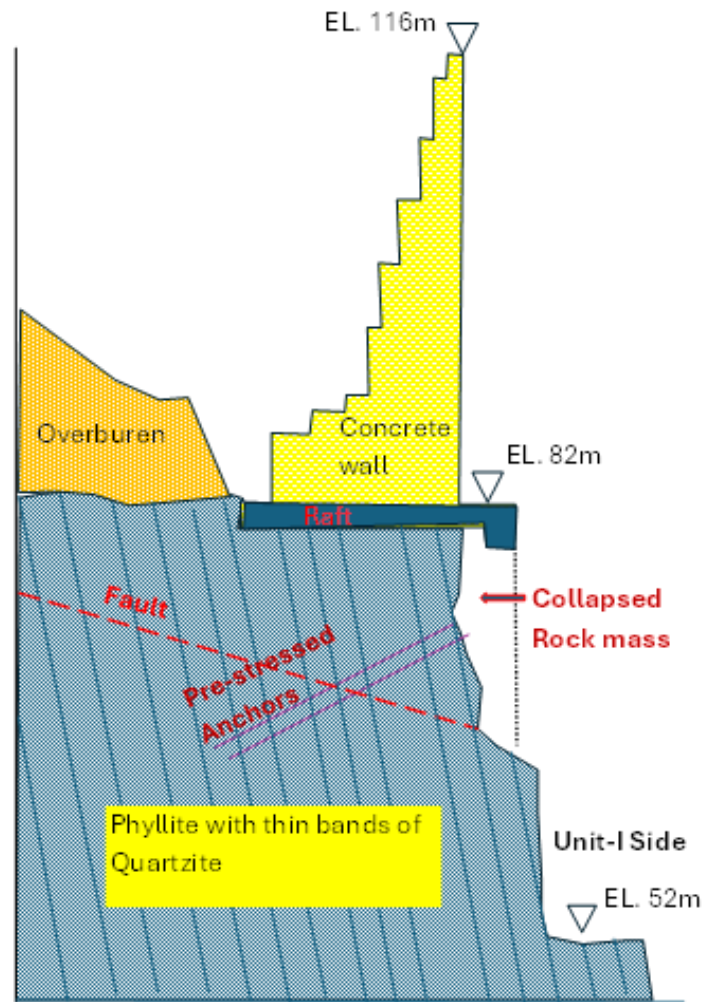
Fig 4. Typical cross-section of Flood Protection Wall and Foundation during Progressive Construction.

Draft tube tunnels of powerhouse were partially excavated in 1976, were left incomplete due to administrative delays. When work resumed in 1982, it was noticed that the rock mass deteriorated with time resulting in roof collapses. Consequently, the remaining tunnels were redesigned as cut and cover structures. Thus, under altered site conditions draft tube tunnels were reconstructed with reinforced concrete. The sudden change in the design necessitated deep open excavation, which in turn created instability in nearby structures, including the service bay columns and the FP wall. This FP wall, standing 34 meters high and constructed in 1982 adjacent to Draft Tube Tunnel No. 1, intersected several shear zones as well as a major fault filled with shattered rock and clay gouge. During excavation, signs of structural distress became evident most notably, a horizontal separation of 39 mm and tilting of 17 mm at RL 92 m, along with additional tilts of 45 mm and 32 mm observed at RL 100 m.

Initially, excavation was restricted to a depth of 8 meters. However, following a tunnel collapse, it had to be extended to approximately 30 meters, reaching below the base of critical structures. This deepening created steep, unsupported slopes, exacerbating the instability. Due to the surrounding structural constraints, reconfiguring these slopes was not feasible, ultimately necessitating a temporary suspension of excavation activities. Subsequently, based on the 2D stability analysis, stabilization measures to prevent collapse of the FP wall were adopted.

the Kadana Dam FP wall, an integrated set of geotechnical treatments was employed to counteract sliding, tilting, and potential failure associated with fault- and foliation-related instability (Fig. 4). These interventions reflect the

Pre-stressed Rock Anchors: Three rows of 100- tonne capacity anchors (10 m length) were installed at 3 m intervals, inclined at 20° across the fault zone. These anchors were tensioned to 80% of their capacity to tie the footwall to the hanging wall of fault, thereby actively resisting sliding of Foundation of FP Wall.

Staged Excavation: The excavation was carefully conducted in 2 m stages, with concrete lifts cast in synchrony to avoid sudden loss of confinement.

Grouting: To seal open joints and consolidate the weak foundation rock, low pressure

grouting was carried out in the foundation.

Drainage Measures: Weepholes and an internal drainage system were installed to reduce pore pressures, control uplift, and drain seepage water. This step was vital to maintain long-term integrity, particularly where open joints, foliation fault were present.
